May 4, 2021
File: N:\ 1446-013-00\L01-1.0

Re: Town of Bassano
Former Stiles Building – Building Assessment

FORMER STILES BUILDING, BASSANO, AB ASBESTOS BUILDING ASSESSMENT

Project# SQJMH21048
APRIL 21, 2021

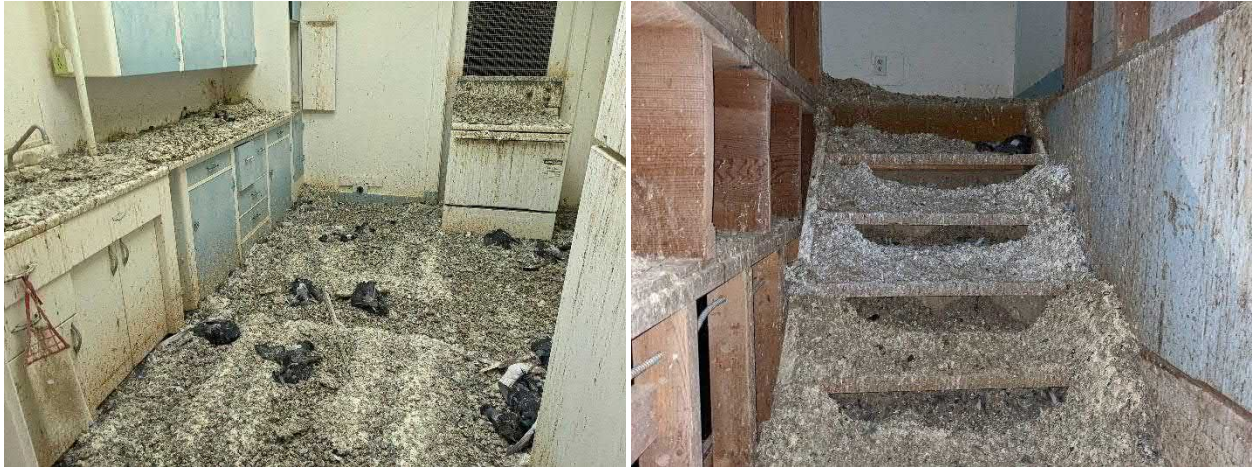
Throughout the entire building carcasses and fecal matter of pigeons were observed. The fecal matter of pigeons, if particles become airborne, can pose an extreme health risk, especially to those with weakened immune systems. The quantity of fecal matter throughout the building varied, as the basement had minimal droppings but increased to as much as 150 mm in depth in the upper floors. Pigeon carcasses were scattered throughout but were more concentrated in the top floor. The fecal matter, carcasses, and any staining will need to be removed due to the health hazard no matter what decision is made with the building.

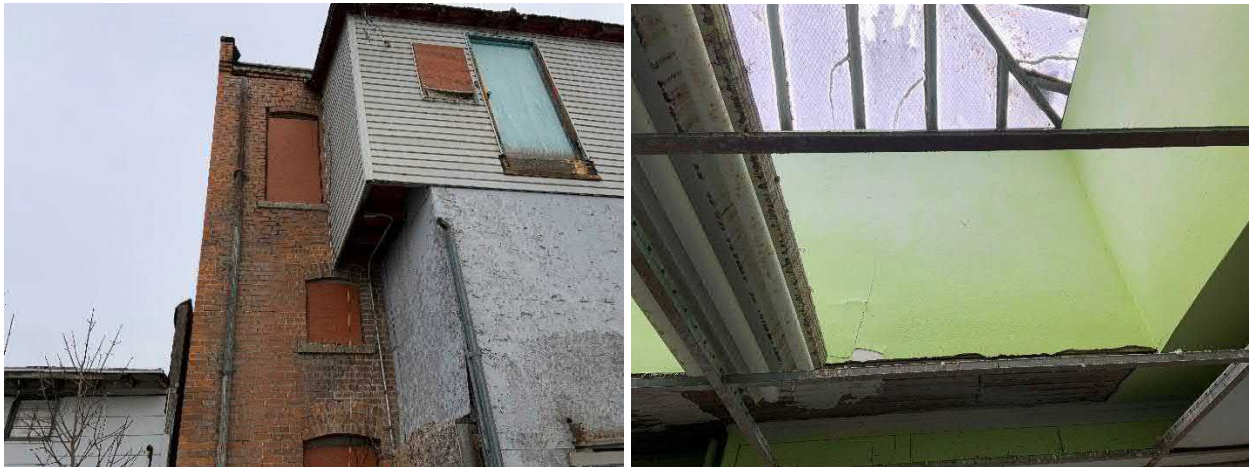
It is likely that the birds came into the building through holes in the building's envelope. The addition on the back of the building appears to have many penetrations in which there is access for the birds to get through. The skylight above the kitchen may be another access point for the bird to get inside. The skylight glass was cracked in several places and one portion of it is boarded up. It appears there was some water infiltration from the skylight as the ceiling directly below has suffered some damage which can be seen at the bottom of the photo above on the right.

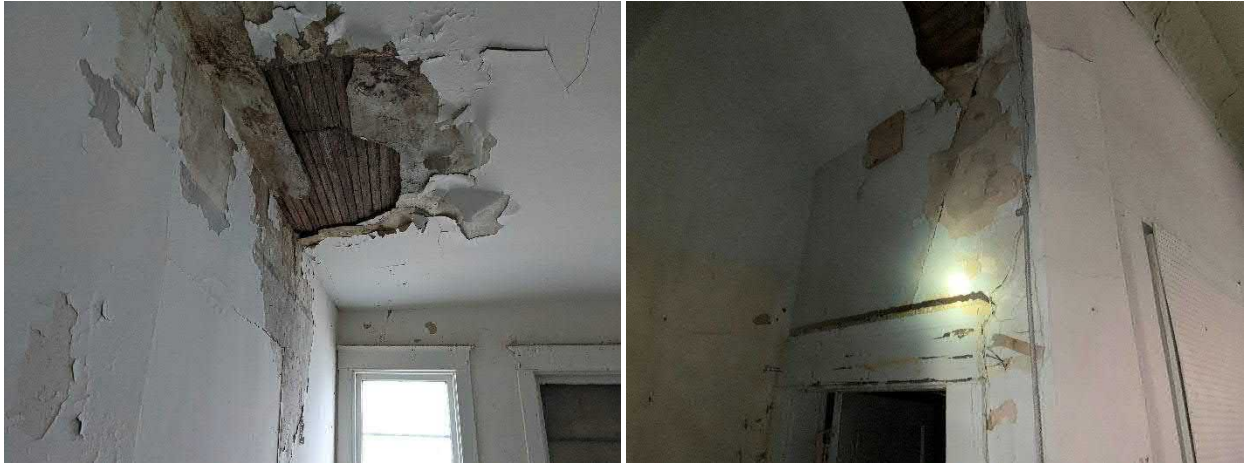
Water damage was observed in the ceiling in several other locations throughout the building. Water damage is likely due to lack of regular maintenance on the building's roof. Assessment of the building's roof and roof structure was not possible due to no access, but it is likely in poor condition given the condition of the ceiling inside. From what could be seen from the ground, flashing has been bent or lifted which would not provide sufficient protection from the elements. The flashing damage can be seen in the photos below. It is likely that water has been infiltrating through the roof for an extended amount of time, resulting in the roof structure needing an entire replacement.

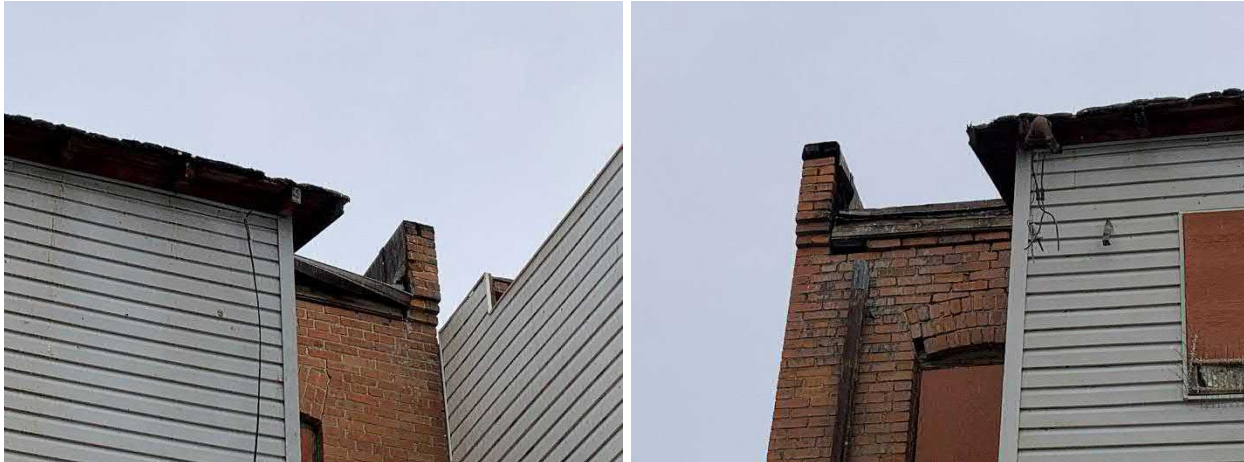
Due to the water infiltration, it is likely that much of the ceiling and within the walls there is a mold infestation. When moist, mold can continue to migrate through the walls and roof system and become health hazard to the building's occupants. Remediation of the mold would be needed as well as air testing to confirm the complete removal of all mold spores. Proper mold remediation would include hiring a contractor who specializes in the remediation of mold.

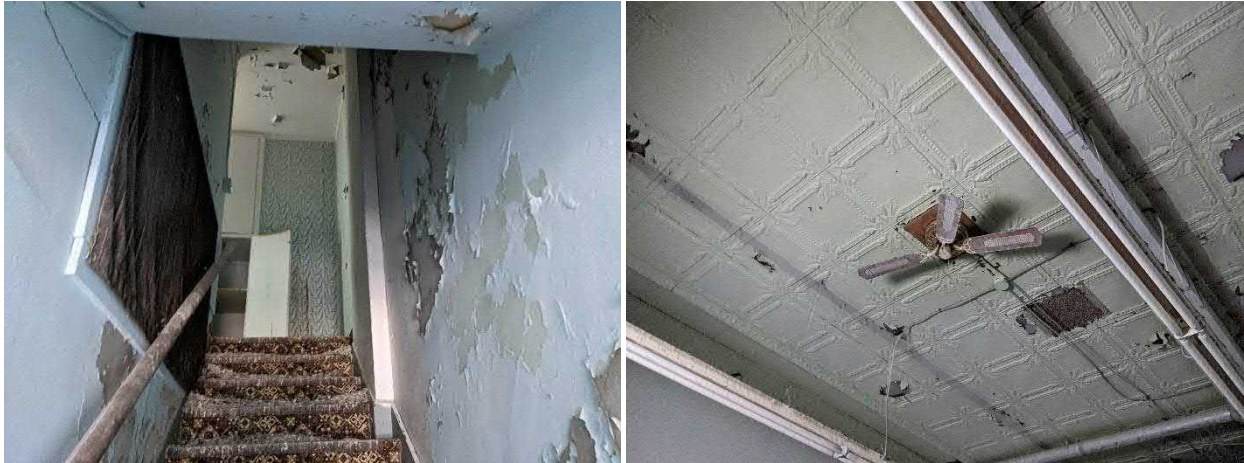
Many of the interior finishes were in poor condition likely due to the combination of age, water damage and the bird infestation. Assessing the condition of the floors throughout the upper levels was nearly impossible due to the layers of fecal matter. It is likely that the floors have been stained/damaged and will require a complete replacement. Some of the interior finishes on the ceilings can likely be refinished and used to keep the historic feel of the building.

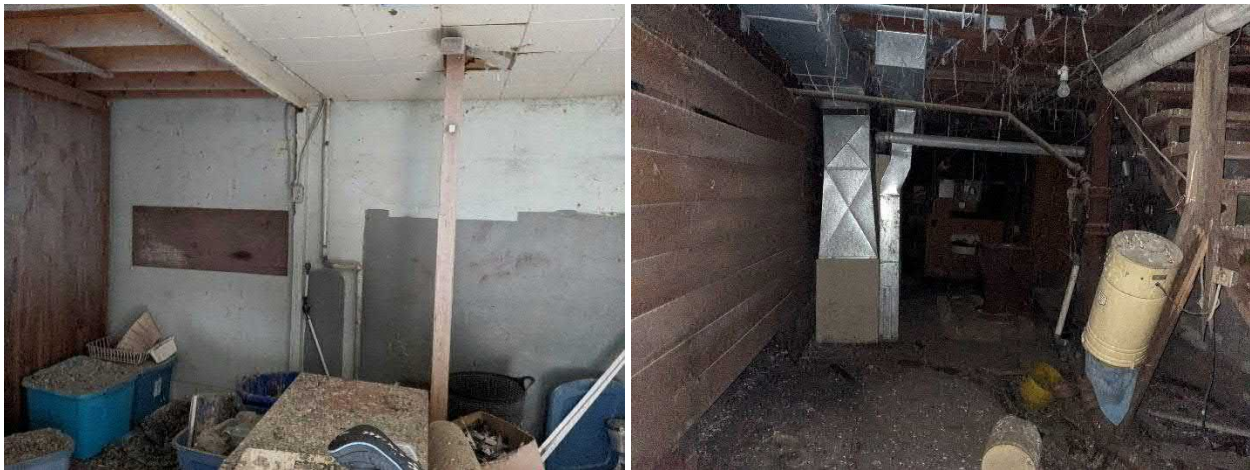
The picture above on the left shows a bowed support beam and a column that has been placed under ceiling tiles. The bowed beam is likely to be passed its deflection limits that would be set forth in the building code, span should be reduced by adding support midspan to lessen the deflection of this beam. Ceiling finishes are not meant to be load bearing surfaces and are not likely to be able bear the loads from floor above. Several structural components appeared to have been added due to changes in the building's occupancy needs. The picture on the left shows some of the structural components that are supporting the mezzanine above the main floor. It is unclear if the mezzanine was added after initial construction. The mezzanine has a low ceiling (approximately 1.75 m, 5.7 ft) with ventilation ducts hanging below the ceiling. The mezzanine does not conform to current building code standards.

It is recommended to remove the back porch due to the condition and poor construction practices used to build it. The same recommendation is afforded to the mezzanine that would does not conform to current building code requirements. The building lacks the height between floors to have the layout that it did at the time of the inspection. The desired layout of the building will help determine the renovated floor plan of the revitalized building.

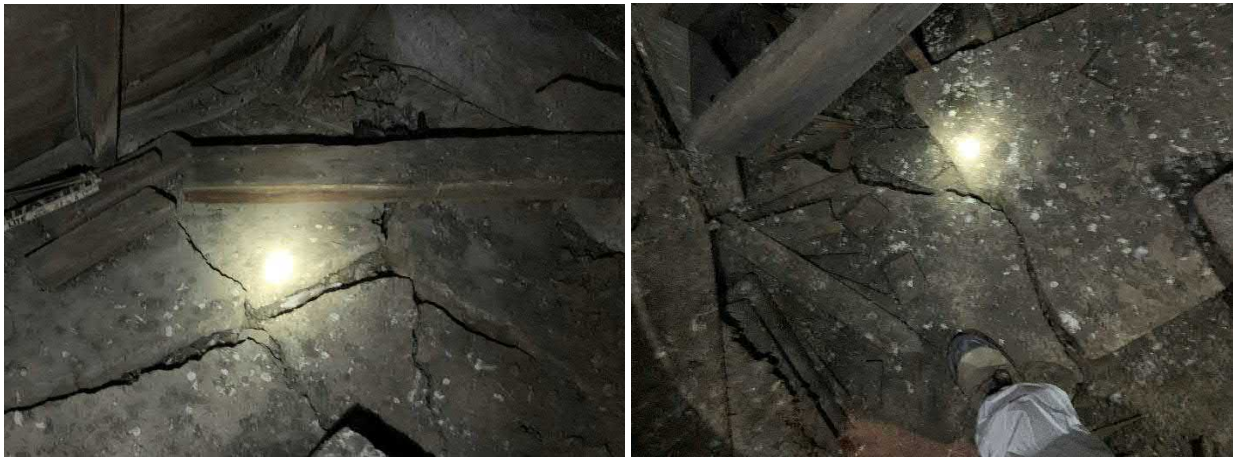
The concrete floors in the basement were in poor condition as the slab was broken into many pieces throughout the concrete floors. The slab that was poured appears to be thin (less than 50 mm). Several factors could contribute to the current condition of the slab including, slab thickness, lack of reinforcing and frost heave. Many tripping hazards are created by the slabs and additional debris found throughout the basement. Removal and replacement of the damaged slab is recommended if the building is refurbished in the future.

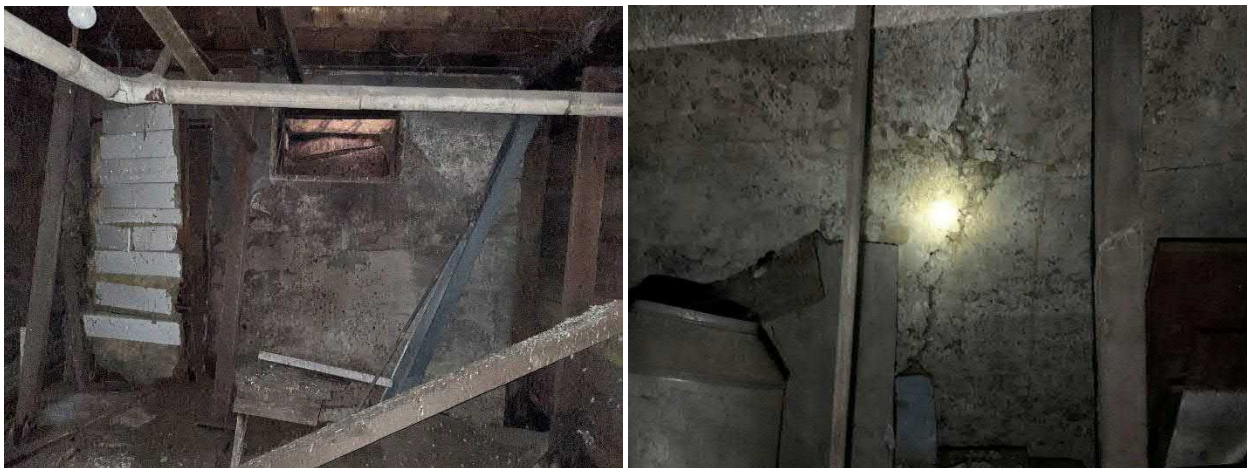
The foundation throughout the basement appeared to be in fair condition for a building of its age. The cracking should be monitored regularly to ensure there it does not worsen. The cracking is likely due to foundation settlement and/or frost heave of the soil. Settlement and foundation cracking is common for a building of this age. Construction methods of the buildings era commonly did not use any reinforcing which has led to the larger cracks which are shown in the picture above on the right. Injection of cracks could help prevent further propagation of the cracks in the concrete. Crack injections can help reduce the possibility of water infiltration which can worsen cracking due to freeze thaw cycles.

The picture above on the left shows a door constructed to retain the soil from the exterior but has since failed and is no longer retaining soil. This failure appears to have affected some of the structural columns in the area as there are columns that have been knocked over and leaning. It is difficult to tell if these columns were part of the original construction or if they were added later. A permanent solution for soil retention can be provided by MPE in the future.

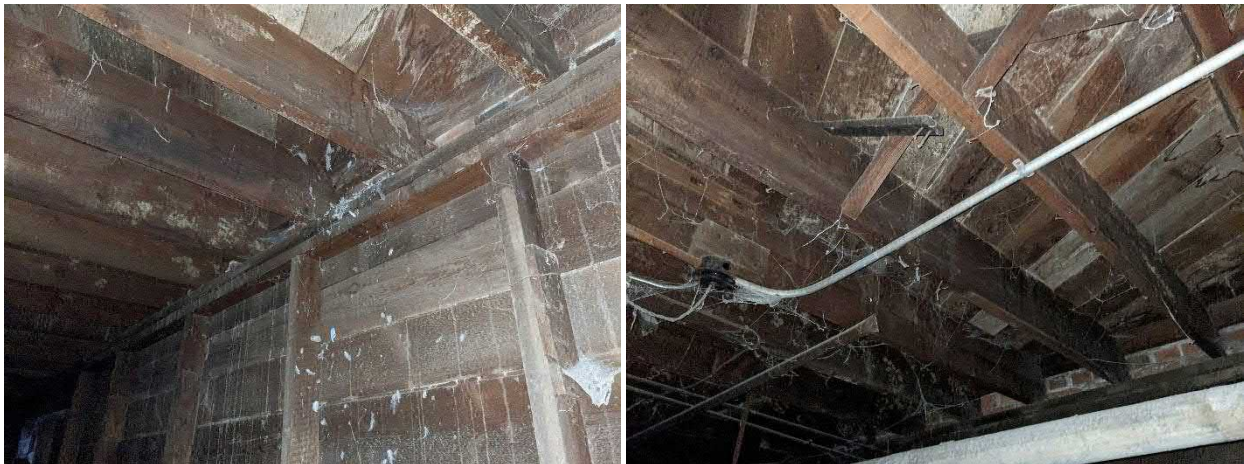
Dry rot was observed on some of the floor joists and floor decking. The dry rot does not appear to be severe enough to be a structural concern at the time of this inspection as its structural integrity is still intact. Some of the x-bracing on the floor joists have fallen off the floor joists. This bracing adds to the stiffness of the floor and should be replaced or blocked with a solid piece of lumber. It was also observed that there was no insulation or vapour barrier in the basement. The lack of insulation and vapor barrier likely contributed to the frost heave and damage to other components of the building.

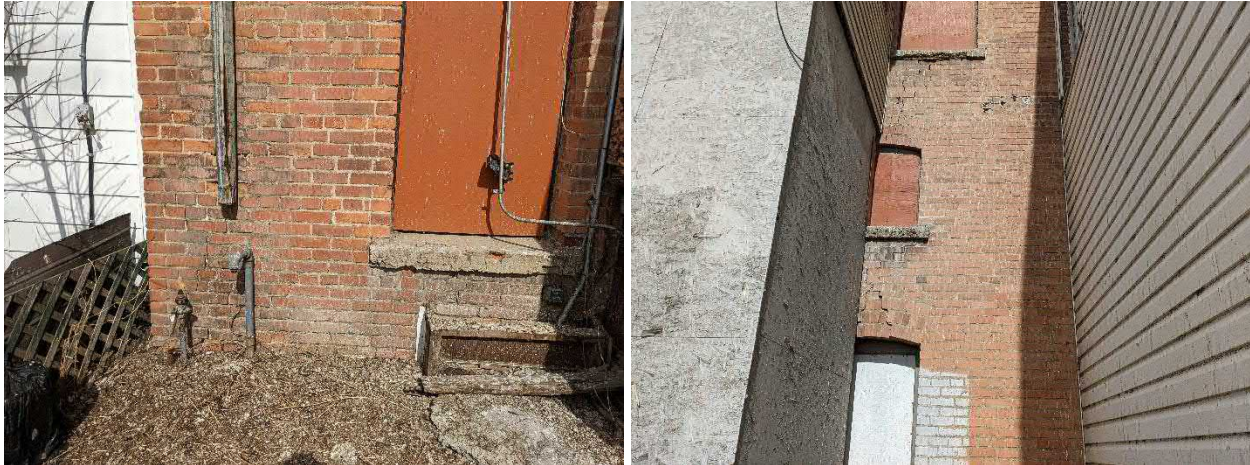
The exterior brick had cracking throughout the building. This is likely due to the settlement and/or frost heave encountered in the foundations. This type of cracking is typical for a building of its age. Another possible factor in foundation movement could be due to the downspout discharging directly against the wall which could allow water to infiltrate next to the foundation wall. The downspout should have an extension so it can disperse water away from the building's foundation. Most of the windows and doors appear to be in poor condition and would likely need to be replaced in order to make the building habitable.

The back porch appears to have been added well after original construction and is in poor condition. The doors and window are no longer in use and have been boarded up. The porch would not conform to current building code requirements. No insulation or vapour barrier was observed throughout the entire porch structure. This is likely one of the main locations of pigeon ingress as there are several openings. The demolition of the back porch should be considered as it appears to be contributing to the degradation of the rest of building.

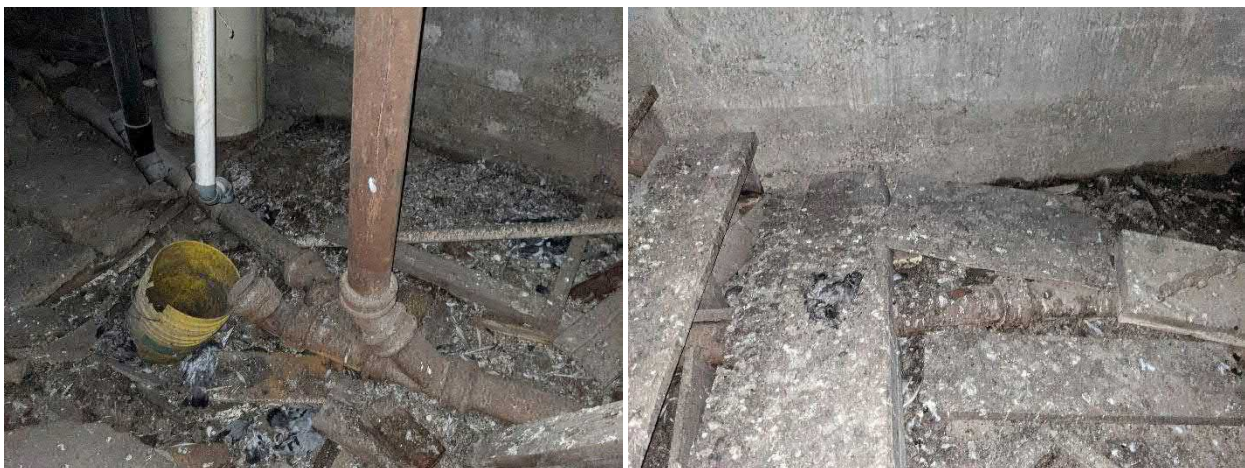
Much of the exposed plumbing appeared to be damaged beyond repair. It appears that the plumbing has either been frozen, shifted due to frost heave, or contacted due to attempted repairs. In the upper floors there were exposed wires hanging from the ceiling, and many lights have been used as perches for birds and have been damaged beyond repair. It is expected that the entire electrical, plumbing, and HVAC systems are beyond repairs and would need to be replaced to bring the building back to an occupiable space.

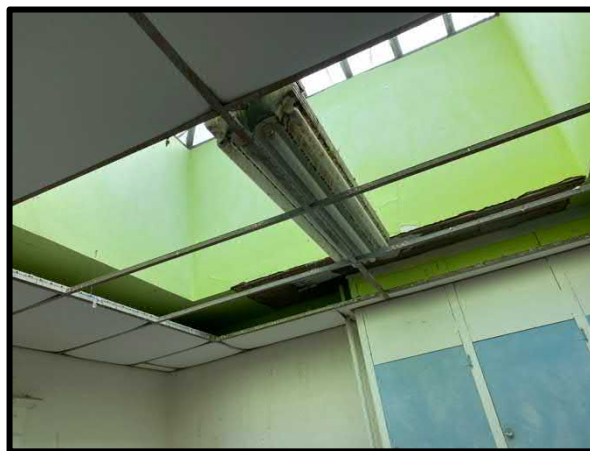
During the building assessment mercury containing lighting tubes were found.

- o Approximately 25 fluorescent lighting tubes were counted throughout the building.

Mercury Containing Fluorescent lighting tubes

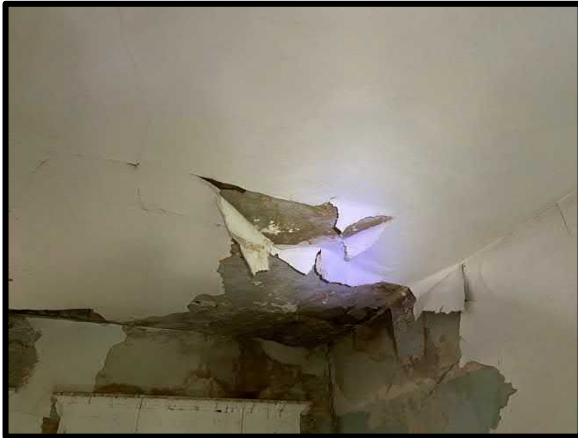
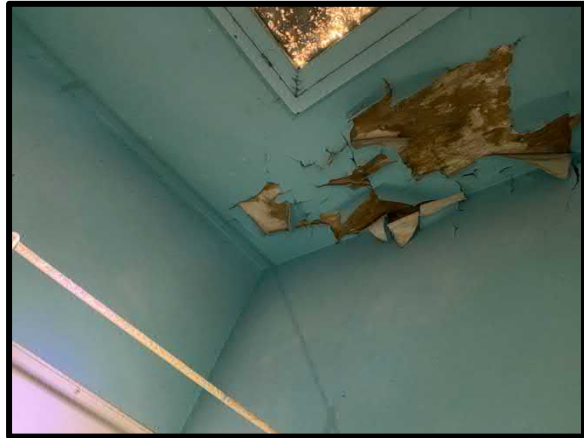
During the assessment visible water damage was observed and noted throughout the building. No visible mould was observed but is suspected.

- o The east doorway of the street sweeper garage

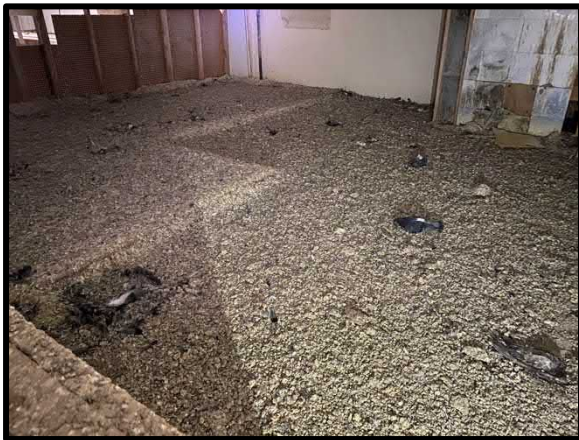
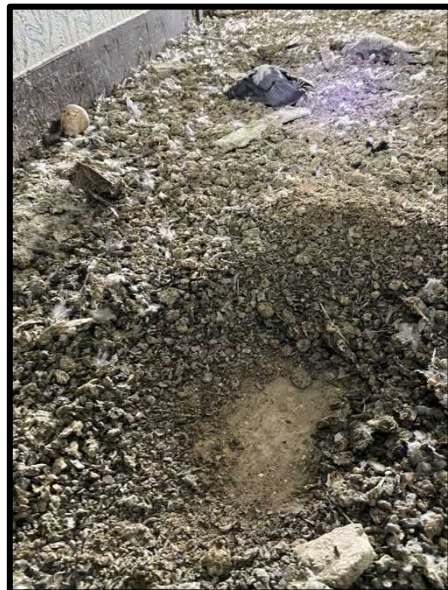
During the assessment large amounts of pigeon fecal contamination was observed. Approximately 30 dead pigeons were also observed throughout the building.
