FORMER STILES BUILDING, BASSANO, AB ASBESTOS BUILDING ASSESSMENT

Project# SQ1MH21048
APRIL 21, 2021

Updated: December 23, 2021

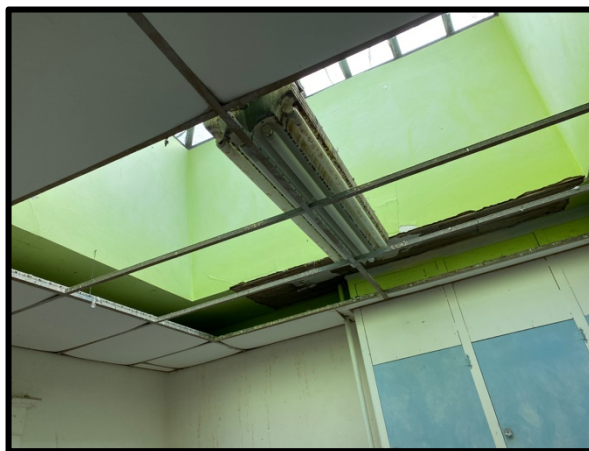
During the building assessment mercury containing lighting tubes were found.

- Approximately 25 fluorescent lighting tubes were counted throughout the building.

Mercury Containing Fluorescent lighting tubes

Fluorescent lighting tubes and thermostats that were identified during the assessment should be disposed of in accordance to the Waste Control Regulations under the Alberta Environmental Protection and Enhancement Act.

All lighting tubes and thermostats have been removed and disposed.

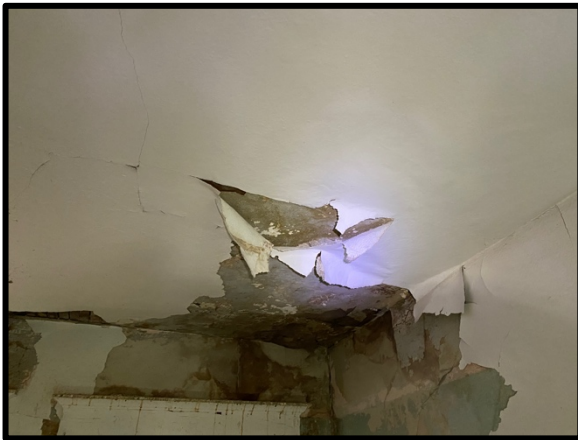
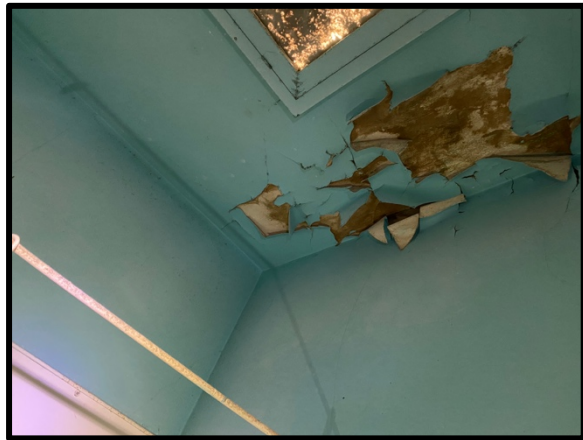
During the assessment visible water damage was observed and noted throughout the building. No visible mould was observed but is suspected.

- o The east doorway of the street sweeper garage

All water damaged materials have been removed and disposed of. Sqrareone can not comment on the water tightness of the building.

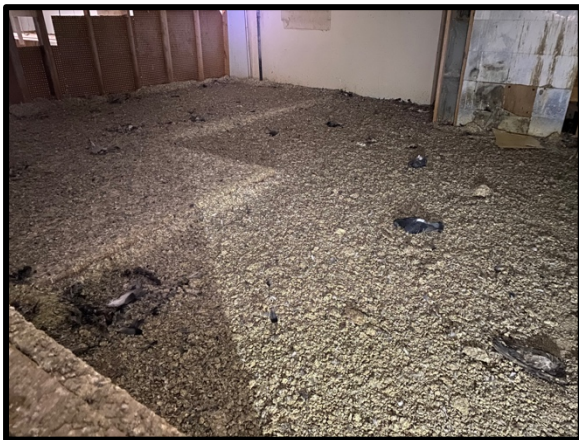
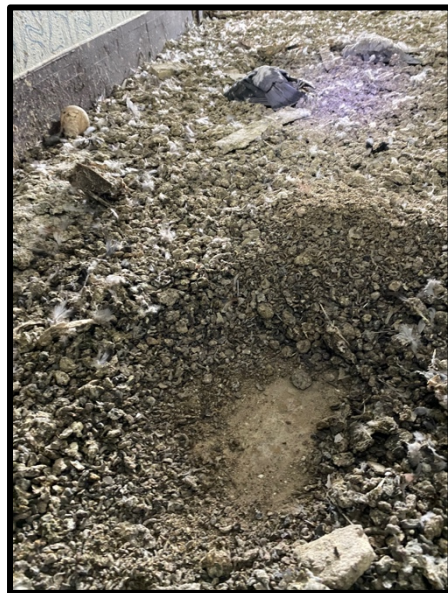
During the assessment large amounts of pigeon fecal contamination was observed. Approximately 30 dead pigeons were also observed throughout the building.

Remediation: Throughout September – November 2021 the town of Bassano acquired the remediation services of Remediclean to remove and decontaminate the entire building of dead pigeons and pigeon waste.

All dead pigeon and pigeon waste has been removed and disposed of. All areas of the building have been disinfected and encapsulated with a fine aerosol glue material.
